Manhole Inspection Summary

Manhole # S41SS_013MH

Insp Date: **2/20/07 9:03 AM**

Location Address: **2581 KIRK AVE**

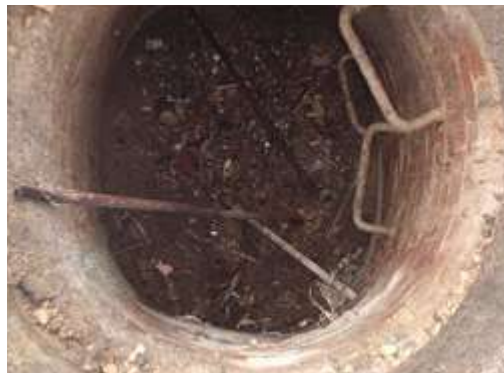
Top View

Channel debris.

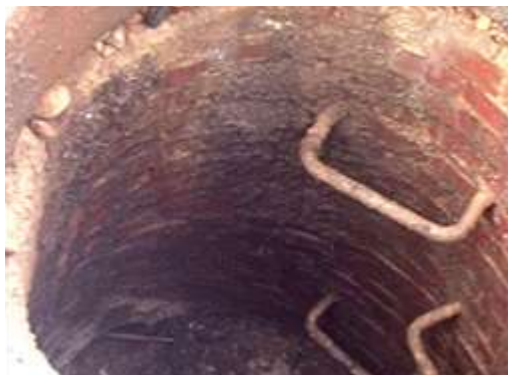
Defect

Frame leaks. Frame offset. Adjustment deterioration and infiltration - other side.

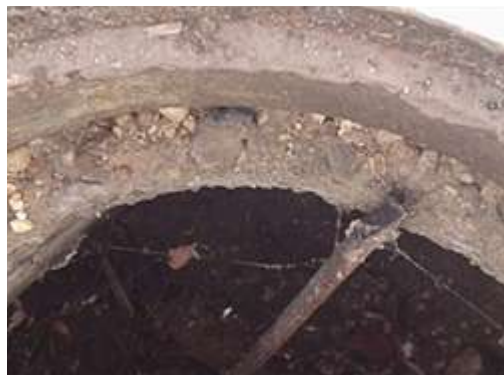
Defect

Frame leaks. Frame offset.

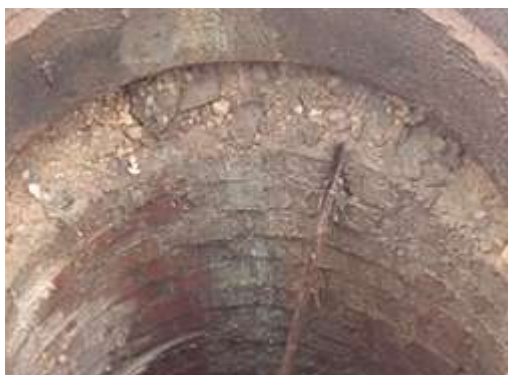
Defect

Frame leaks. Frame offset. Adjustment deterioration and infiltration.

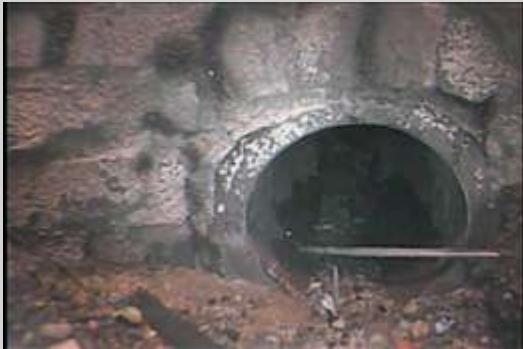
8 in. Circular Gravity Sewer
Pipe Out @ 12 O'Clock

Deposits: ☐ None ☒ **Mud** ☐ Sludge ☒ **Debris** ☐ Grease

Silt Depth: **0.5** (in.) Deposits Extent: **Light**
